**PUBLIC SUMMARY REPORT**

**INITIAL RSPO CERTIFICATION ASSESSMENT**

**SIME DARBY PLANTATION Sdn Bhd**  
**Management Unit PTSIA**

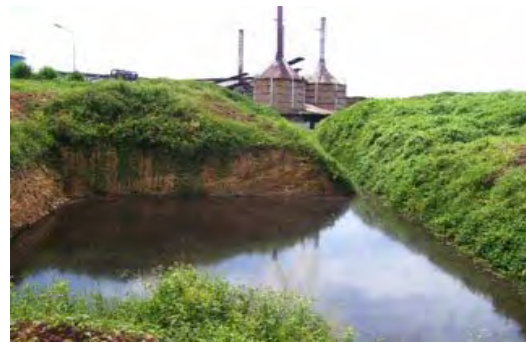
**Plate 1: Pond for Treatment of EFB Stockpile Drainage**

**Indicator 4.4.2:** A Nonconformity (CR06) was assigned against this minor compliance indicator as inspection showed the Water Management Plan was inadequately implemented as the monsoon drain silt traps were filled with sediment and drainage from the EFB stockpile was discharged offsite without adequate treatment.

Inspection of the EFB Stockpile area on 29 April 2009 confirmed that drainage was being treated in a settling pond (Plate 1). Work had been commenced on diverting the drainage from the EFB stockpile area to a sump for transfer to the effluent treatment ponds. The volume of the EFB stockpile had been reduced significantly and the mill was on track with its target to recycle all of the EFB to the field.

**The nonconformity (CR06) against Minor Compliance Indicator 4.4.2 was closed out.**

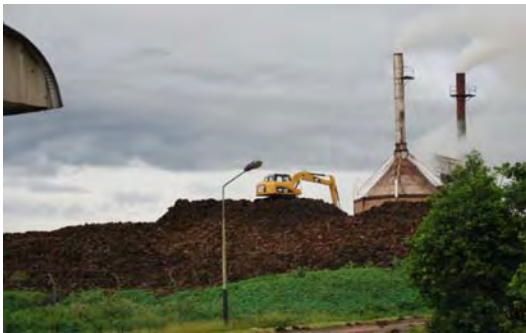
**Plate 2: Large Stockpile of EFB and Incinerators used for disposal November 2008**

**Indicator 5.6.3:** A Nonconformity (CR09) was assigned against this minor compliance indicator as approximately 80 percent of EFB is burned in the low temperature incinerators at the Mill (Plate 2). The resulting bunch ash is utilised by the estate as fertiliser for replacement of Potash. There is no programme for phasing out of incineration of EFB.

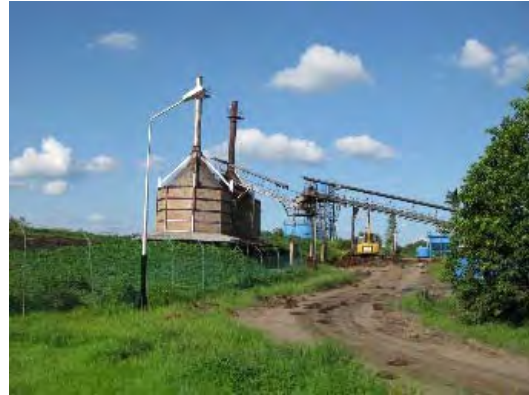
**Plate 3: EFB being loaded onto trucks for recycling to smallholders (April 2009)**

The EFB stockpile area was inspected by the BSi Lead Assessor during the follow-up site visit on 29 April 2009. PTSIA had conducted awareness to the smallholders on the benefits of applying EFB as mulch to replace chemical fertiliser. EFB was being back-loaded onto trucks and supplied to smallholders. The operation of the incinerators had ceased and the EFB stockpile had been reduced significantly (Plate 3).

**The nonconformity (CR09) against Minor Compliance Indicator 5.6.3 was closed out as the incineration of EFB had ceased and there was evidence of EFB recycled to the Estates and Smallholders.**

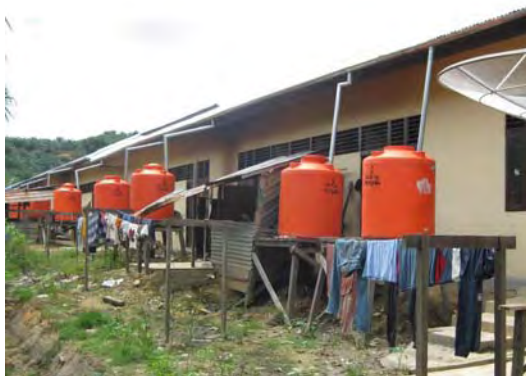
**Plate 4: Newly Constructed Worker Housing with Tanks installed for Rainwater Harvesting**

- The Estate previously used paraquat but usage ceased before the merger of the companies in November 2007.
- PTSIA has commenced a program to replace the older timber housing with brick buildings. The first unit had been recently constructed at East Estate. At the new housing, tanks have been installed and connected to roof guttering to harvest rainwater.
